## E1551.06-113-11-R0 ACOUSTICAL PERFORMANCE TEST REPORT ASTM E 90 AND ASTM E 492

#### **REGUPOL AMERICA**

Series/Model: 3 mm Regupol Sonus Rubber Underlayment

Specimen Type: Floor/Ceiling Assembly

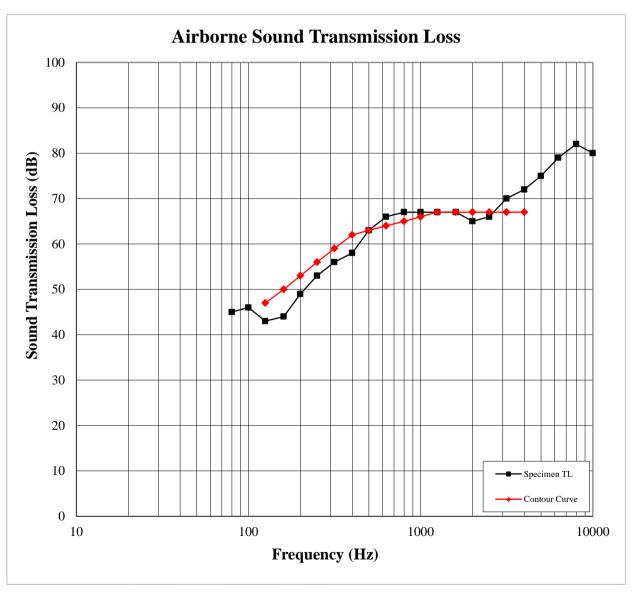
# AIRBORNE SOUND TRANSMISSION LOSS ASTM E 90

<b>Test Date</b>	10/14/14
Data File No.	E1551.06
Client	Regupol America
Description	7 mm Ceramic Tile, 3 mm Regupol Sonus Rubber Underlayment, 152 mm Concrete Slab, 0.5 mm Armstrong HD8906 Drywall Main Beam, 0.5 mm Armstrong XL8945P Cross Tee, 88.9 mm Johns Manville Kraft-Faced R13 Fiberglass Insulation, 15.88 mm Gold Bond® Fire-Shield® Type X Gypsum Panel
Specimen Area	10.98 m²
Technician	Leeland S. Hoover

Freq	Background	Absorption	Source	Receive	Specimen	95%	Number
Treq	SPL	Tibsoi ption	SPL	SPL	TL	Confidence	of
(Hz)	(dB)	$(m^2)$	(dB)	(dB)	(dB)	Limit	Deficiencies
80	53.8	10.0	104	60	45	6.30	-
100	43.8	6.6	103	60	46	7.60	-
125	40.1	8.4	107	67	43	5.60	4
160	30.8	5.5	101	62	44	5.50	6
200	27.7	6.6	97	52	49	2.20	4
250	25.7	6.9	99	50	53	2.00	3
315	24.8	6.1	99	47	56	2.80	3
400	23.6	5.8	97	43	58	1.30	4
500	23.4	4.9	99	41	63	1.00	0
630	23.7	5.4	100	39	66	1.30	0
800	22.8	4.8	100	38	67	1.50	0
1000	25.2	5.3	100	37	67	0.80	0
1250	24.2	5.2	100	38	67	0.60	0
1600	20.8	5.0	100	37	67	0.60	0
2000	15.2	5.8	100	39	65	0.90	2
2500	11.8	6.1	99	37	66	0.80	1
3150	10.4	6.4	99	33	70	0.90	0
4000	9.9	7.1	100	30	72	0.50	0
5000	9.3	8.4	99	26	75	0.60	-
6300	9.1	10.6	93	15	79	0.70	-
8000	9.1	12.9	92	11	82	0.80	-
10000	9.1	15.9	87	7	80	1.20	-

STC Rating 63 (Sound Transmission Class)

Deficiencies 27 (Sum of Deficiencies)

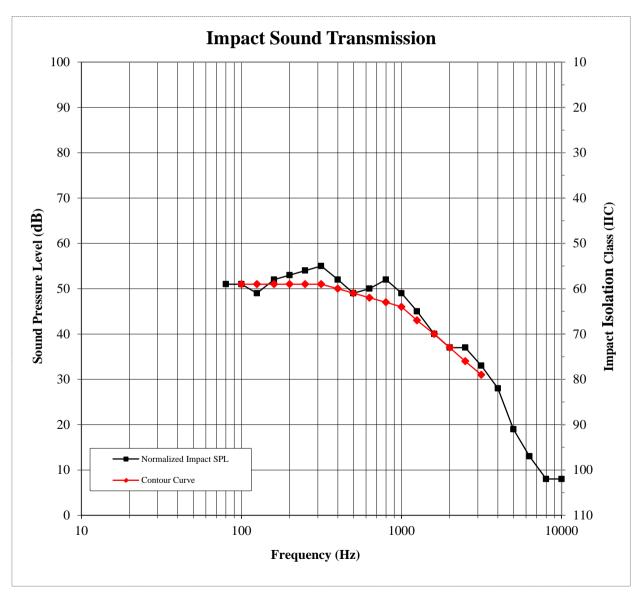
# IMPACT SOUND TRANSMISSION

Test Date	10/14/14
Data File No.	E1551.06
Client	Regupol America
Description	7 mm Ceramic Tile, 3 mm Regupol Sonus Rubber Underlayment, 152 mm Concrete Slab, 0.5 mm Armstrong HD8906 Drywall Main Beam, 0.5 mm Armstrong XL8945P Cross Tee, 88.9 mm Johns Manville Kraft-Faced R13 Fiberglass Insulation, 15.88 mm Gold Bond® Fire-Shield® Type X Gypsum Panel
Specimen Area	10.98 m²
Technician	Leeland S. Hoover

Freq	Background SPL	Absorption	Normalized Impact SPL		Number
				Confidence	of
(Hz)	(dB)	(m²)	(dB)	Limit	Deficiencies
80	50.3	16.9	51	7.0	-
100	41.0	10.0	51	2.6	0
125	38.2	9.6	49	2.9	0
160	29.6	8.7	52	2.9	1
200	26.4	10.1	53	3.8	2
250	25.2	10.1	54	3.1	3
315	22.2	9.2	55	3.5	4
400	21.6	7.9	52	1.3	2
500	21.7	7.0	49	1.3	0
630	21.7	7.1	50	1.9	2
800	20.8	7.4	52	1.0	5
1000	24.8	7.2	49	1.0	3
1250	22.9	7.3	45	1.6	2
1600	19.4	7.2	40	2.1	0
2000	12.7	8.1	37	1.7	0
2500	9.4	8.9	37	2.8	3
3150	7.4	9.4	33	2.7	2
4000	6.6	10.3	28	3.7	-
5000	6.2	11.8	19	3.1	-
6300	6.4	14.3	13	3.0	-
8000	6.6	18.3	8	0.8	-
10000	6.7	22.7	8	0.3	-

IIC Rating61(Impact Insulation Class)Deficiencies29(Sum of Deficiencies)

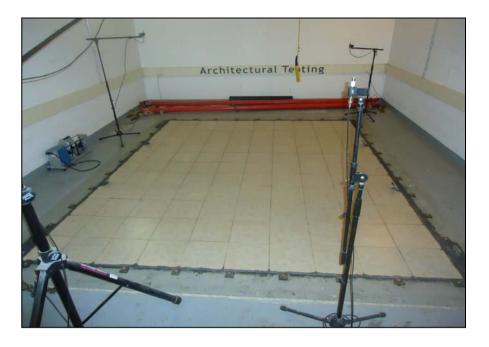
**Source Room View of Test Specimen Installation**

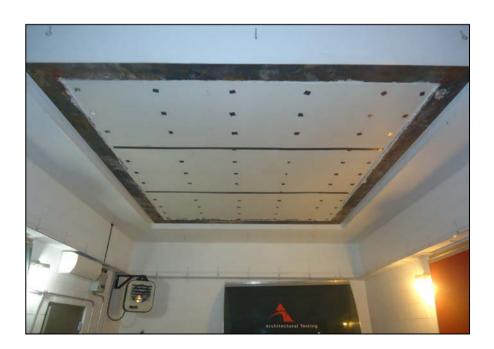
**Receive Room View of Test Specimen Installation**

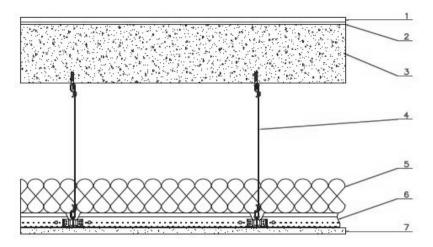
# Drawing

- 1-Floor topping
- 2-Underlayment
- 3-Concrete Slab
- 4-Hanger Wire
  - 5-Insulation
- 6-Ceiling Grid
  - 7-Ceiling

rest specimen iv	Dimensions	Thickness			A mamaga	
Material	(mm)	(mm) Manufacturer and Series		Quantity	Average Weight	
	304.8 by 304.8	7.0	N/A	10.98 m²	14.09 kg/m²	
Ceramic Tile	Note: Grout was placed into the 6.35 mm joints between the ceramic tile and wiped clean. The ceramic tile was placed with light pressure onto a bed of mortar on the underlayment. The mortar was set using a 6.35 mm by 6.35 mm trowel. Both the grout and mortar were allowed to cure to manufacturer's specifications.					
Rubber	3048 by 1219.2	3.0	Regupol Sonus	10.98 m²	2.49 kg/m <sup>2</sup>	
Underlayment	Note: Loose laid.					
Concrete Slab	3023 by 3632	152.0	N/A	10.98 m²	366.18 kg/m²	
	Note: The concrete slab was installed in a test frame flush to the source room.					
Drywall Main Beam	38.1 by 43 by 2870	0.5	Armstrong HD8906	10.9 m²	0.45 kg/m <sup>2</sup>	
	Note: Twelve gauge hanger wires were attached to the bottom side of the concrete at twelve locations

and then to the main beams. The hanger wire was twisted around itself a minimum of three times					
	within 76 mm creating a 305 mm plenum.

Material	Dimensions (mm)	Thickness (mm)	Manufacturer and Series	Quantity	Average Weight			
Cross Tee	38.3 by 37.3 by 1219	0.5	Armstrong XL8945P	27.2 m²	0.45 kg/m²			
Closs Tee	Note: Inserted into the main beams on 607 mm centers.							
Fiberglass Insulation	2962 by 584	88.9	Johns Manville Kraft-Faced R13	10.98 m²	1.33 kg/m²			
	Note: Loose laid onto the ceiling grid system.							
Gypsum Panel	1219 by 3032	15.9	Gold Bond® Fire-Shield® Type X	10.56 m <sup>2</sup>	11.23 kg/m²			
	Note: Fastened with fine thread drywall screws on 305 mm centers.
