D8974.01-113-11-R0 ACOUSTICAL PERFORMANCE TEST REPORT ASTM E 90, ASTM E 492, ASTM E 2179

Regupol® SonusTM HS300 3 mm Underlayment

Specimen Type: Floor/Ceiling Assembly

Report
 D8974.01-113-11

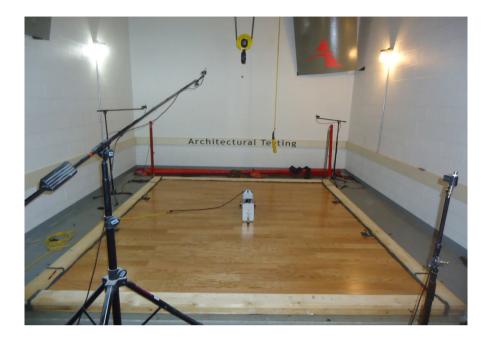
Source Room View of Test Specimen Installation

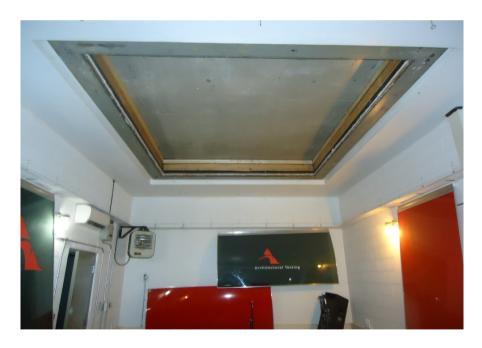
Receive Room View of Test Specimen Installation
